Final Report on a Project Designed to Reduce Damage to Sinking Groundlines by Adjusting Lobster Gear Hauling Equipment

Submitted to NOAA Fisheries
by

Richard Allen
R. B. Allen Associates
145 High St. # A
Westerly, RI 02891

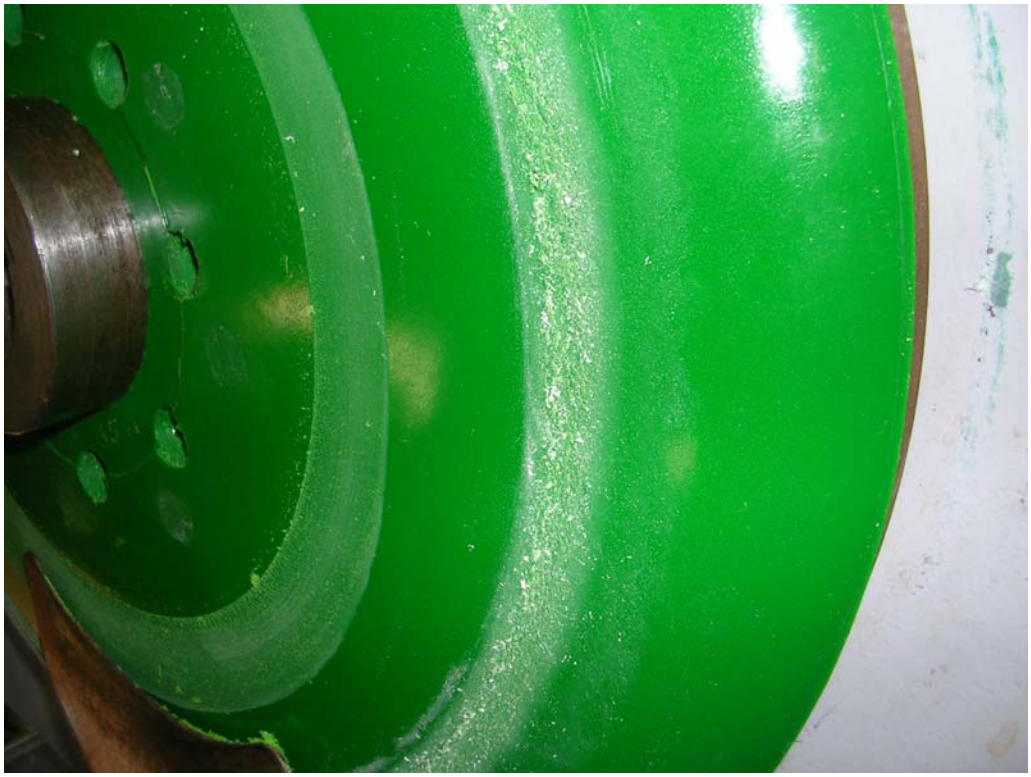
Treatment 12 utilized polyurethane sheaves with a hardness, or durometer, designated as 47 Shore D, which might be characterized as a medium hardness. The configuration included a standard steel splitter and zero spacing between the sheaves. The 47 Shore D sheaves showed a statistically significant improvement in rope wear compared to standard machined-steel sheaves, but the sheaves showed excessive wear that would not mak e them practical for commercial use.

Figure 17. 47 Shore D polyurethane sheaves showed excessive wear after a short period of simulated hauling.

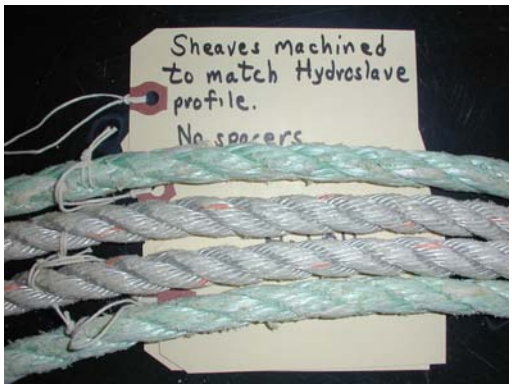
Figure 18. Rope samples from Treatment 19, sheaves machined to match Hydroslave variable surface angle stamped steel sheaves. The aqua colored rope is Polysteel © floating rope and the gray rope is a blended polyester and Polysteel © sinking rope.

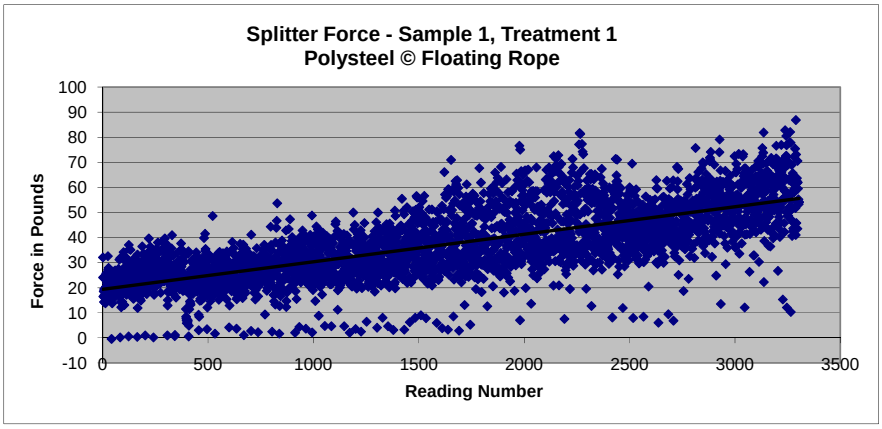
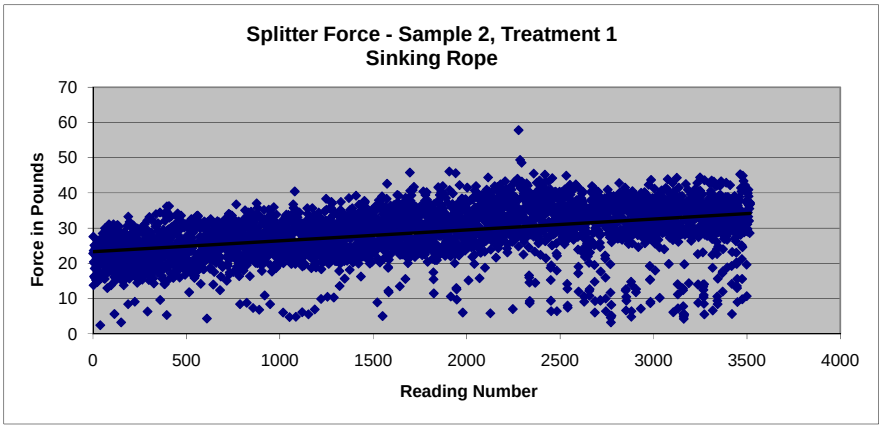
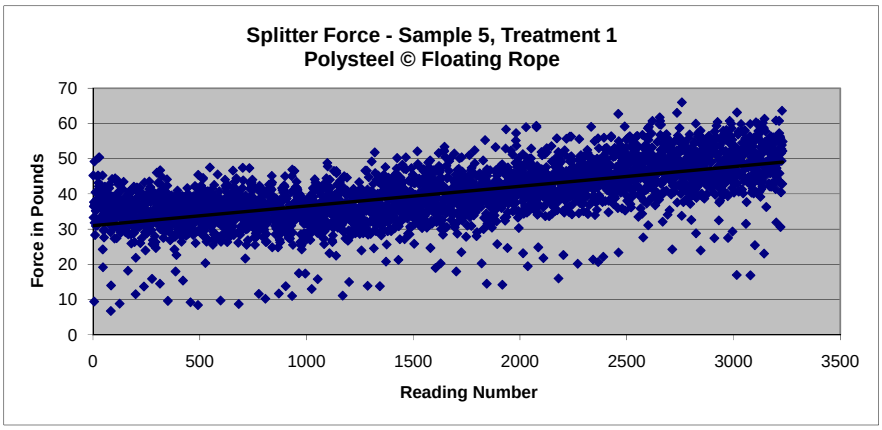
Figure 26. A graph of splitter force readings together with the trend line for the data points shows a continuous increase in the force required to push the rope out from between the sheaves over the duration of a test run of 125 hauling cycles. This data is from the runs 1, 2 and 5 (the load cell failed and the data from samples 3 and 4 were discarded). All of these runs used standard machined-steel sheaves with 0.1" spacing and a standard splitter. Note the lower starting point for run 1 compared to the others, and the steeper increase to a higher end point. Subsequent runs showed a higher mean force but with less of an increase from start to finish and a lower end point.

We assume that an increase in splitter force over the course of a run could be explained by the rope squeezing further between the sheaves as the rope wore out. The increasing roughness of the surface of the rope may have also increased the friction between the rope and the sheaves, increasing the force needed to push the rope out of the sheaves.

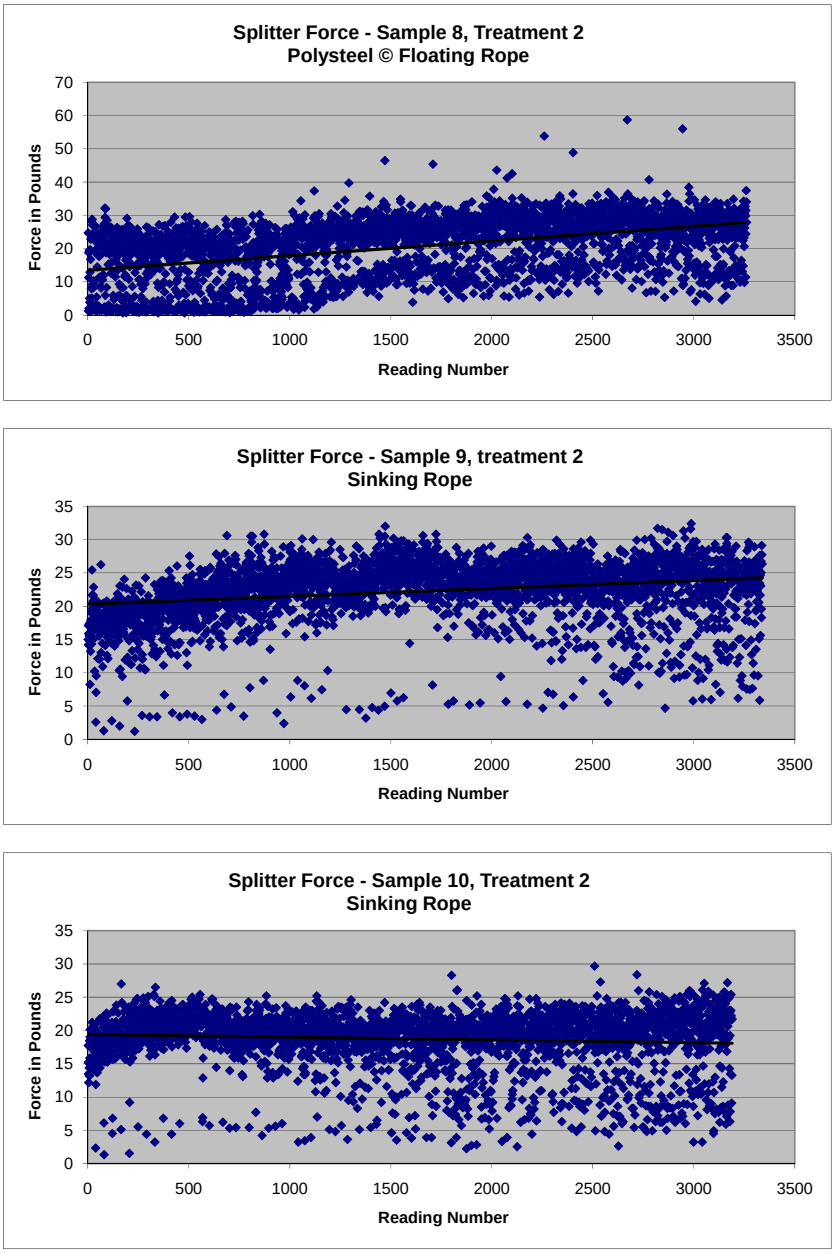
Figure 27. The mean force with which the rope pushes against the low-angle-of-incidence splitter is considerably less than that observed with the standard splitter and shows less of an inclination to increase from the beginning of a run to the end. These graphs represent data from the first three runs with the modified splitter (Treatment 2)

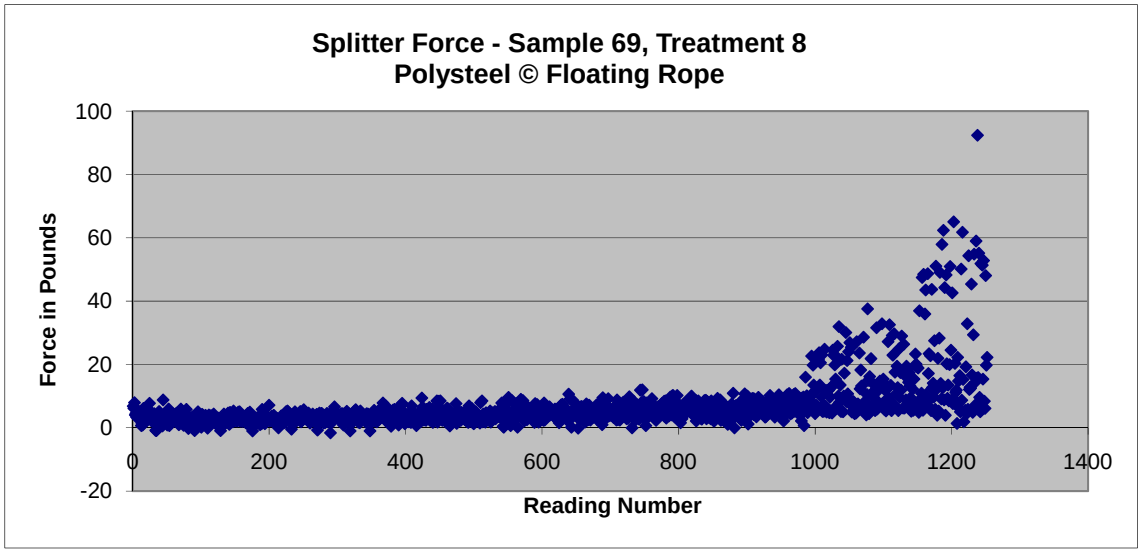
An interesting pattern of increasing force against the splitter load cell was apparently connected to the snapping of hauler bolts that occurred during the testing of sample 69 of Treatment 8, with no spacer between the Hydroslave stamped-steel variable angle sheaves. There is very little force on the splitter until the heads of the hauler bolts start snapping off. A total of three bolts snapped off, which probably allowed the sheaves to spread on one side and close up on the other, perhaps gripping the splitter in the process and increasing the reading on the load cell. Sample 69 was the last of eight runs with the same hauler set-up, which obviously created a lot of stress in the hauler bolts.

Figure 28. Sample 69 of Treatment 8 showed low splitter force readings until the heads of the hauler bolts started snapping off, at which time the splitter force readings increased dramatically with the loss of each bolt. A total of three of the eight hauler bolts snapped off during this run. Sample 69 was the last of eight runs with the same hauler set-up, which obviously created a lot of stress in the hauler bolts.
