Greater Atlantic Region Policy Series [23-01]

# **The Effects of Tide Gates on New England Wetlands and Other Tidal Resources**

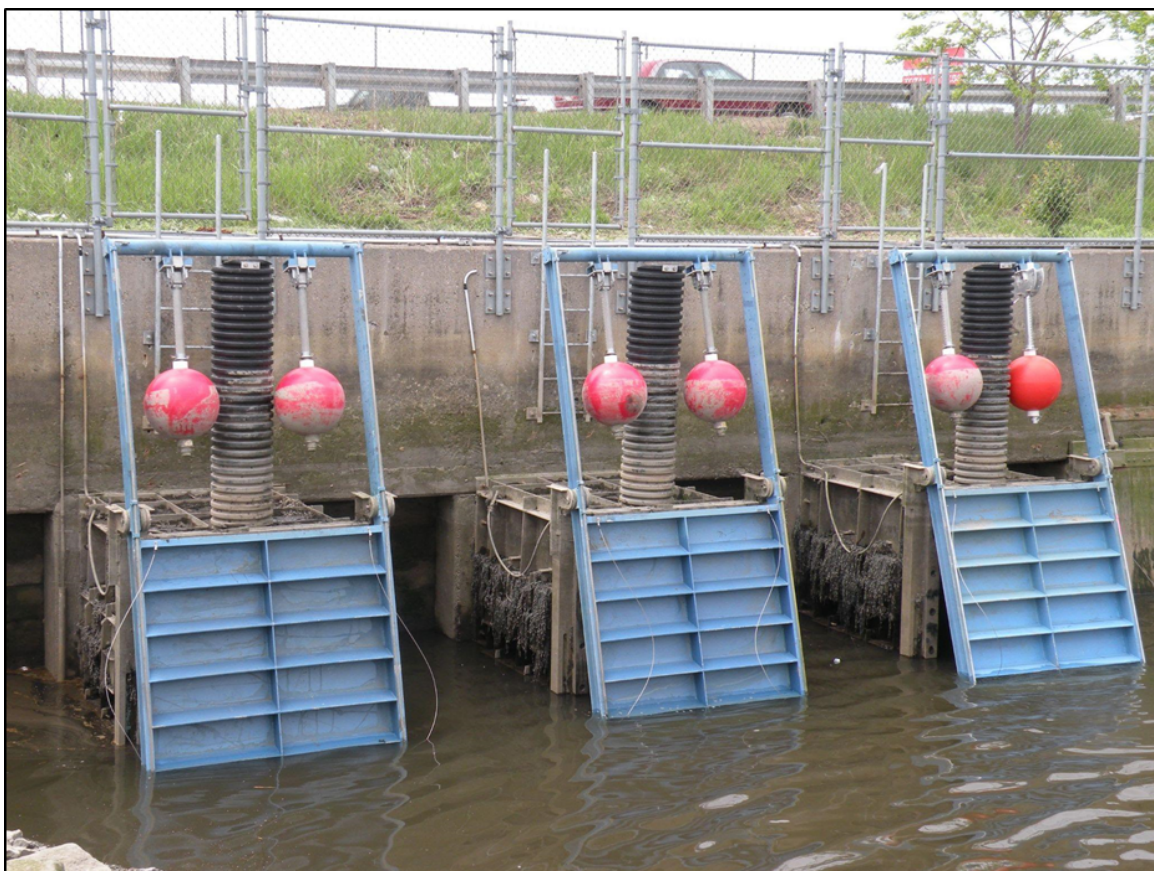
Self-regulating tide gates (SRTs) use a top-hinged buoyant valve that opens with an incoming tide to allow saltwater to flow into the up-gradient, tidally-restricted areas and to tidal wetlands (Figure 1). The buoyant valve is counterpoised with adjustable back floats whose greater buoyancy counteracts the buoyant valve so as to close the gate at predetermined, adjustable water levels for flood protection of interior areas. Similar to conventional top-hinged tide gates, on the ebb tide the hydraulic force of the water pushes the gate open when the head pressure is higher on the interior, allowing for upstream drainage. The SRTs can also be deployed in a cantilevered, normally-open position using weights installed in the back-arm assembly. This installation method is particularly useful to avoid premature closure of the gate valve from hydraulic forces in the confined vault.

**Figure 1.** Self-regulating tide gates with floats at Route 1, Town Line Brook, Revere, Massachusetts. Photo credit: Edward Reiner, US EPA.

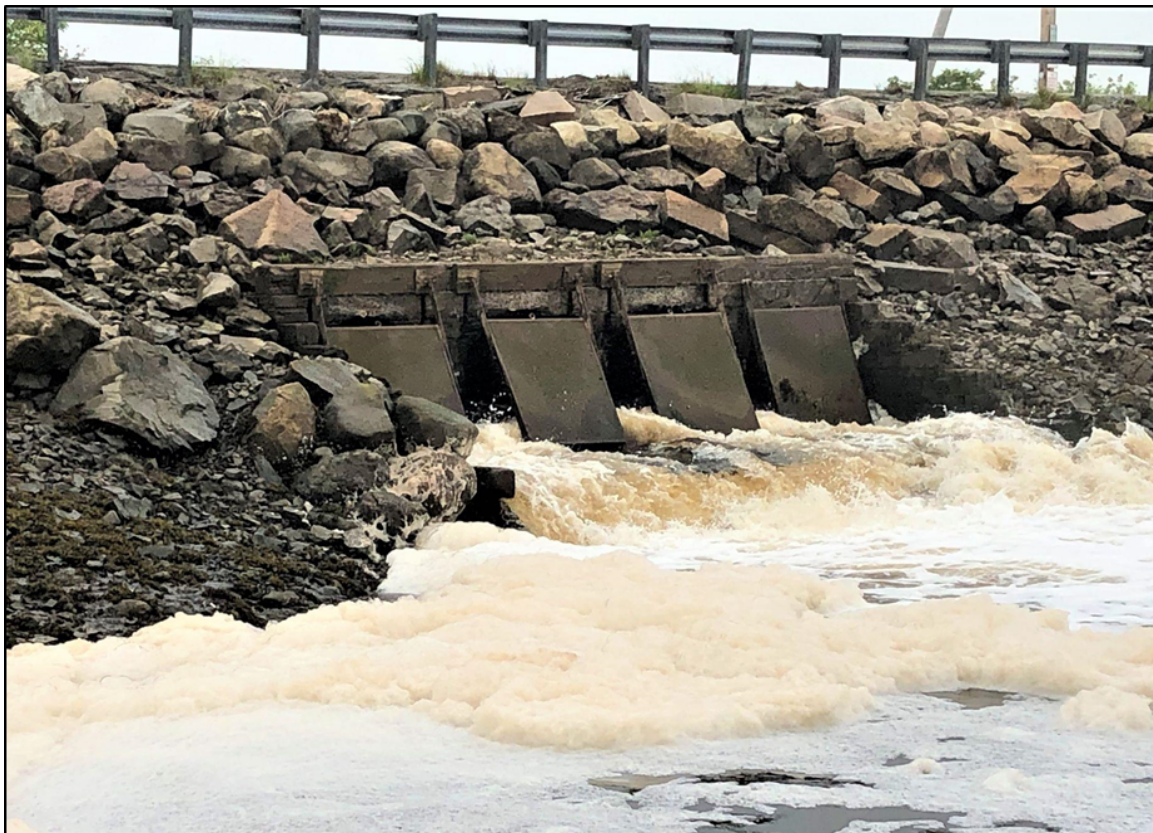
Traditional tide gates or passive control structures typically use flapper gates with either a heavy lid (made of treated wood) attached at the top of the culvert by either a bar with hinges or chains, or a metal lid (usually of cast iron or steel) and double hinged from above (Figure 2). Alternative flapper designs include side-hinged gates and top-hinged gates with small “pet doors” that are located within the larger and heavy hinged flapper

**Figure 2.** Traditional, top-hinged flapper gates with metal lids, Machias, Maine. Photo credit: Matt Bernier, NOAA Fisheries.

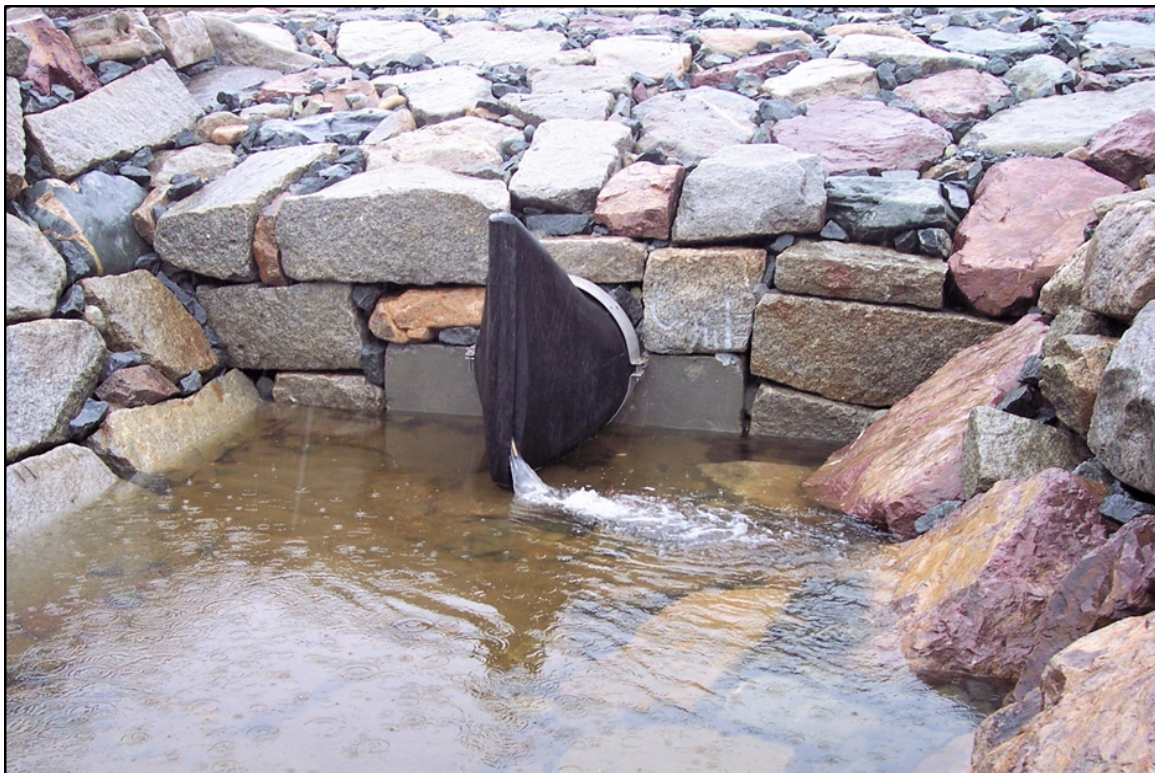
Lastly, there are tide gates that are designed to prevent all tidal flow by use of tightly fitting rubber check valves, which can be installed inside of the culvert, or rubber “duckbill” tide gates installed on the outlet culvert, which only allows for downstream flow (Figure 3).

**Figure 3.** A rubber duckbill-type tide gate, Swampscott, Massachusetts. Photo credit: Edward Reiner, US EPA.

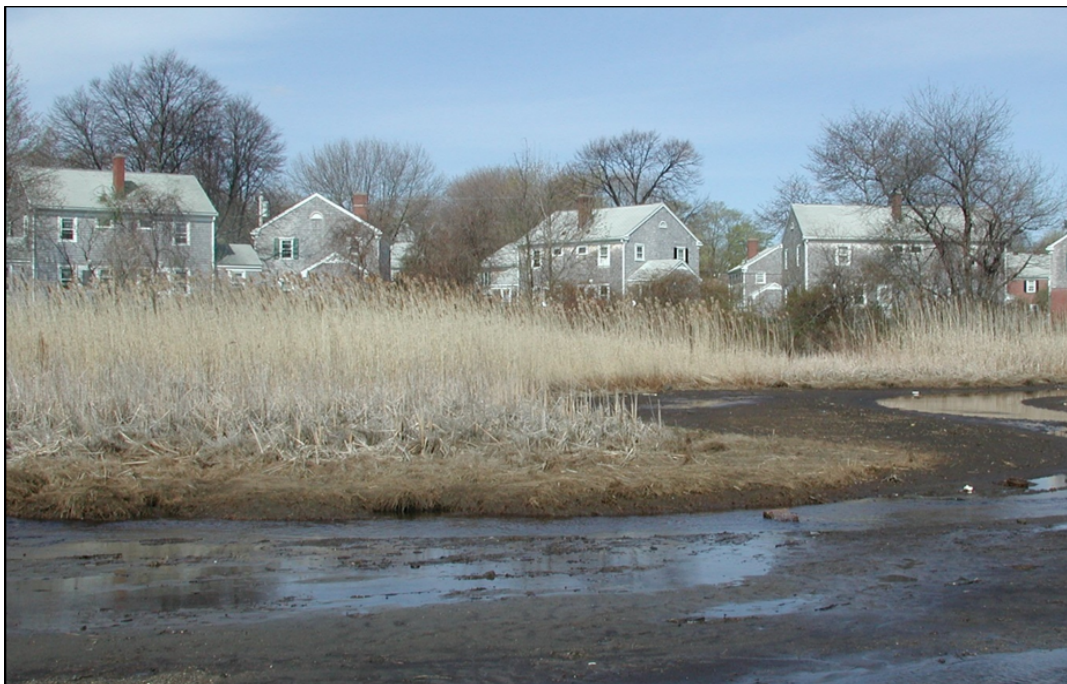
Tide gates can alter the hydrology of coastal wetlands, particularly for high salt marsh communities, and negatively affect the species that depend upon them. Tide gates can reduce the tidal amplitude and duration of inundation in salt marsh wetlands, alter the salinity of soils and increase the prevalence of invasive plant species such as *Phragmites* (Burdick et al. 2001; Chambers et al. 1999) (Figure 4).

**Figure 4.** *Phragmites*-dominated marsh upstream of the Gloucester Mills tide gate, Gloucester, Massachusetts. Photo credit: Eric Hutchins, NOAA Fisheries.

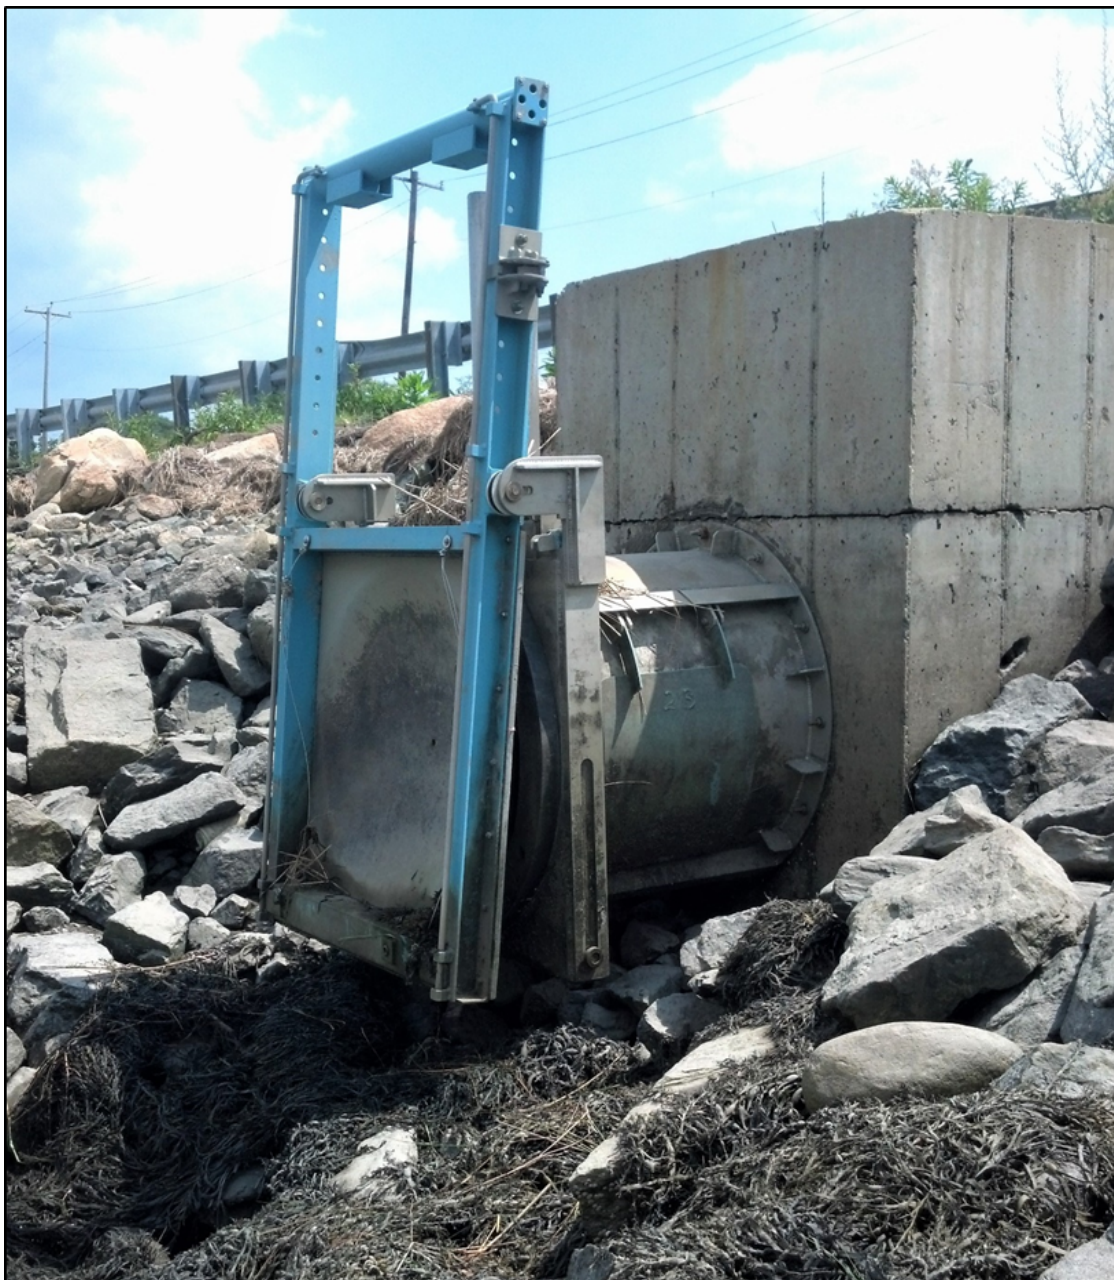
**Broken Hardware:** Tide gates undergo continuous wear and tear under normal operating conditions. Parts such as hinges, screws, floatation, gaskets and other hardware and mechanical parts deteriorate over time and become prone to breakage. For example, in the summer of 2021, the Oak Island tide gate in Revere, Massachusetts malfunctioned due to some mechanical parts breaking. Over the course of several months, the Revere Department of Public Works (RDPW) attempted without success to find a contractor to fix the problem or to find the unique replacement parts. It was not until the fall of 2022 that this tide had been repaired (E. Hutchins, pers. comm. 2022). In two other examples within Rumney Marsh in Revere, Massachusetts, the Massachusetts Department of Transportation (MADOT) replaced a series of top-hinged, cast iron tide gates with SRTs that had become inoperable between 1997 and 1999 (i.e., Route 1A improvements and Town Line Brook). The U.S. Environmental Protection Agency (EPA) issued non-compliance reports for these projects to inform the U.S. Army Corps of Engineers and the MADOT of needed repairs to these flood control structures (EPA 2018a; 2018b). As of the date of this publication, repairs to these structures have not been completed (Figure 5).

**Figure 5.** SRT gate on Route 1A in Revere, Massachusetts, showing missing top floats broken at the hinge joint of the top float assembly. Photo credit: Edward Reiner, US EPA.

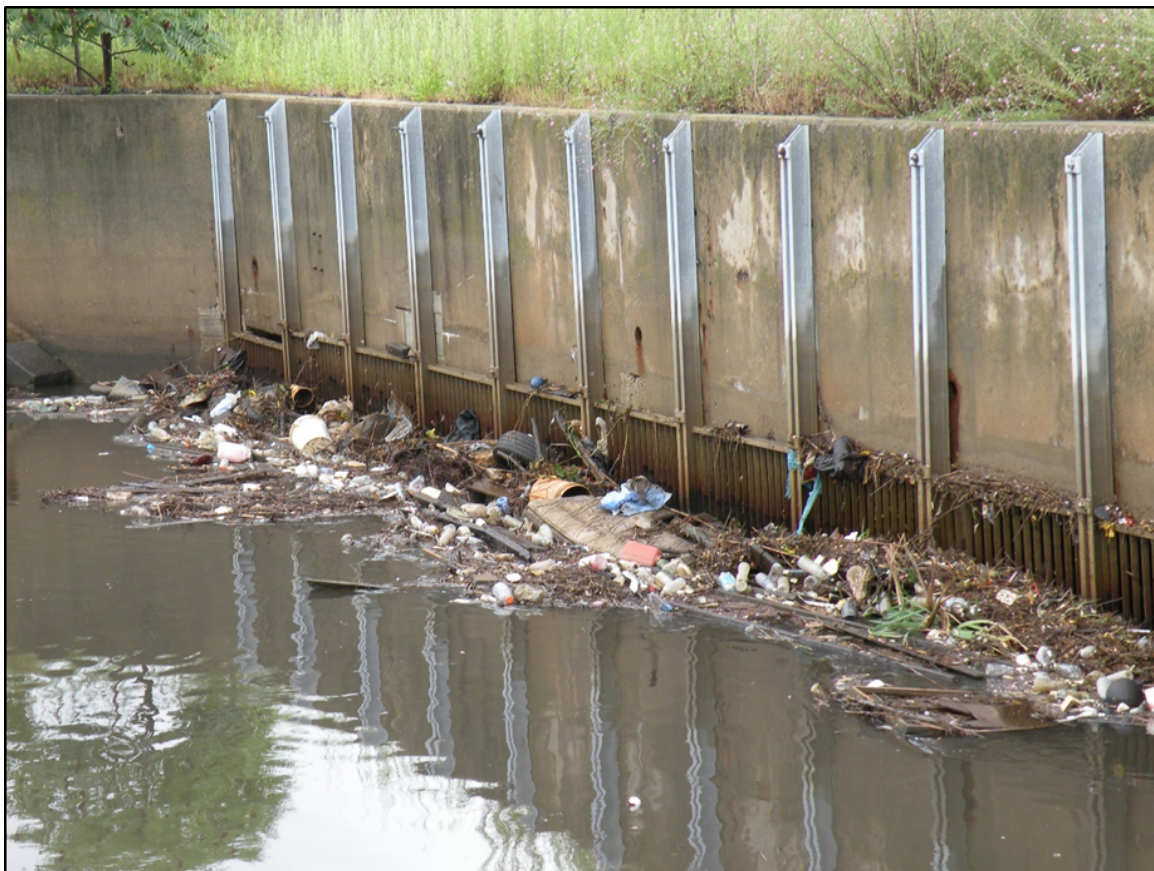
**Debris Blockages:** Both natural (e.g., fallen trees) and man-made debris (e.g., tires) can lodge themselves in the opening of a tide gate or obstruct hinges or other moveable parts and shut down normal operations until the obstruction is manually cleared away. Many tide gates are installed with trash racks, which can also be impacted by the accumulation of debris and cause backwater flooding of upstream areas. Remote locations of tide gates often make them difficult for local public works staff to reach and clear debris. In addition to field staff, debris clearing often requires heavy machinery and access is often difficult. As noted above, several of the SRTs installed in Rumney Marsh by MADOT are not operating properly due to sediment and debris accumulation (EPA 2018a; 2018b) (Figure 6).

**Figure 6.** Debris in front of clogged trash rack on upstream side of Route 1, Town Line Brook tide gate, Revere, Massachusetts. Photo credit: Edward Reiner, US EPA.

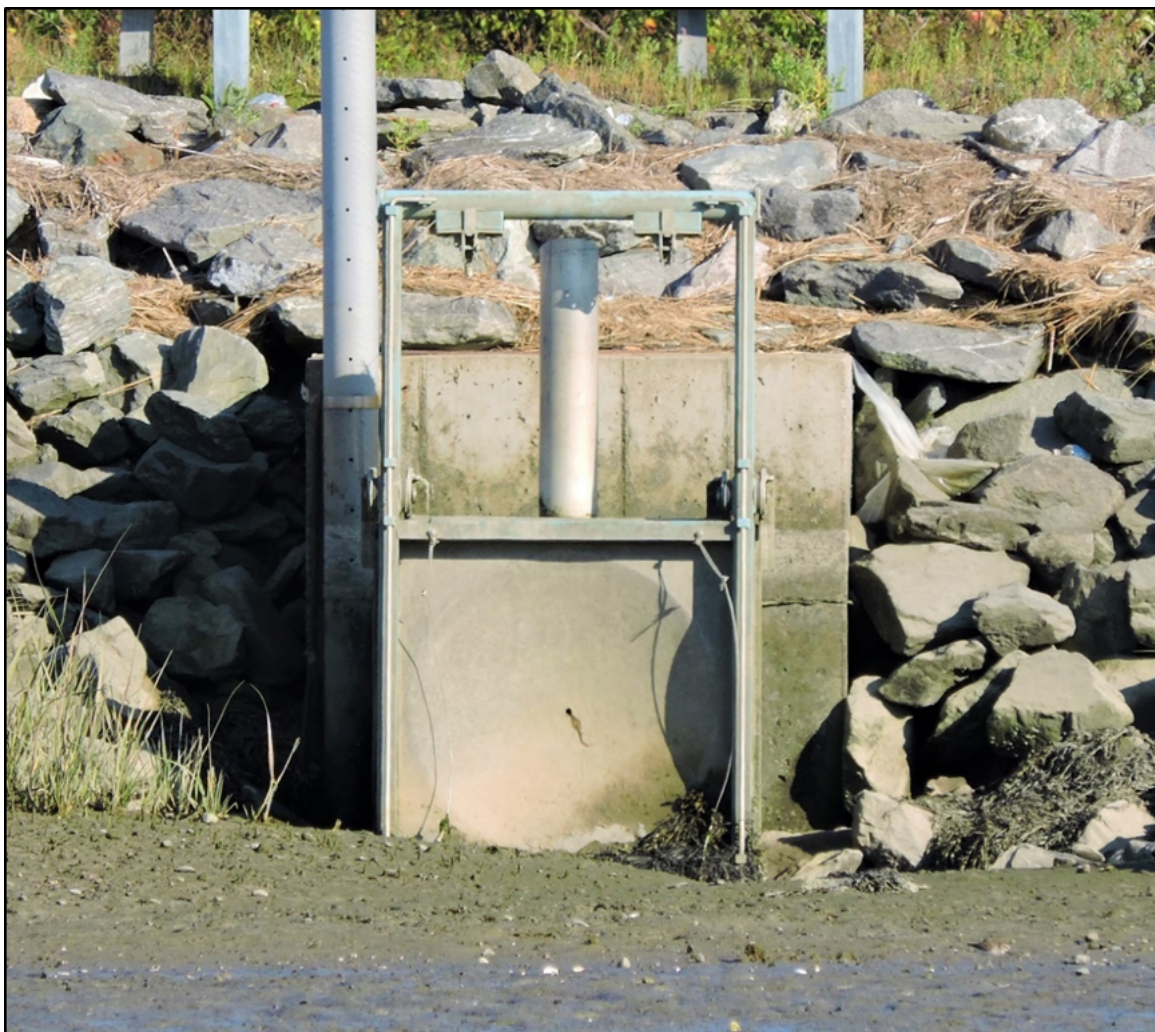
**Vandalism:** Acts of vandalism have been reported at a number of tide gates impairing the intended operation. In recent times, it is possible that high values of scrap steel and aluminum have led people to dismantle tide gates in order to sell the metal for scrap. For example, several incidents of vandalism of tide gates in Rumney Marsh, Massachusetts were reported to the MADOT and U.S. Army Corps of Engineers (Reiner 2012) (Figure 7).

**Figure 7.** SRT gate on Route 1A in Revere showing missing top floats broken at the hinge joint, likely the result of vandalism. Photo credit: Edward Reiner, US EPA.
